Reviving a broken legend

Deciphering the repair history on a classic sports car has enabled XJR-14 chassis No 591 to ride - and win - again

BY MIKE FULLER

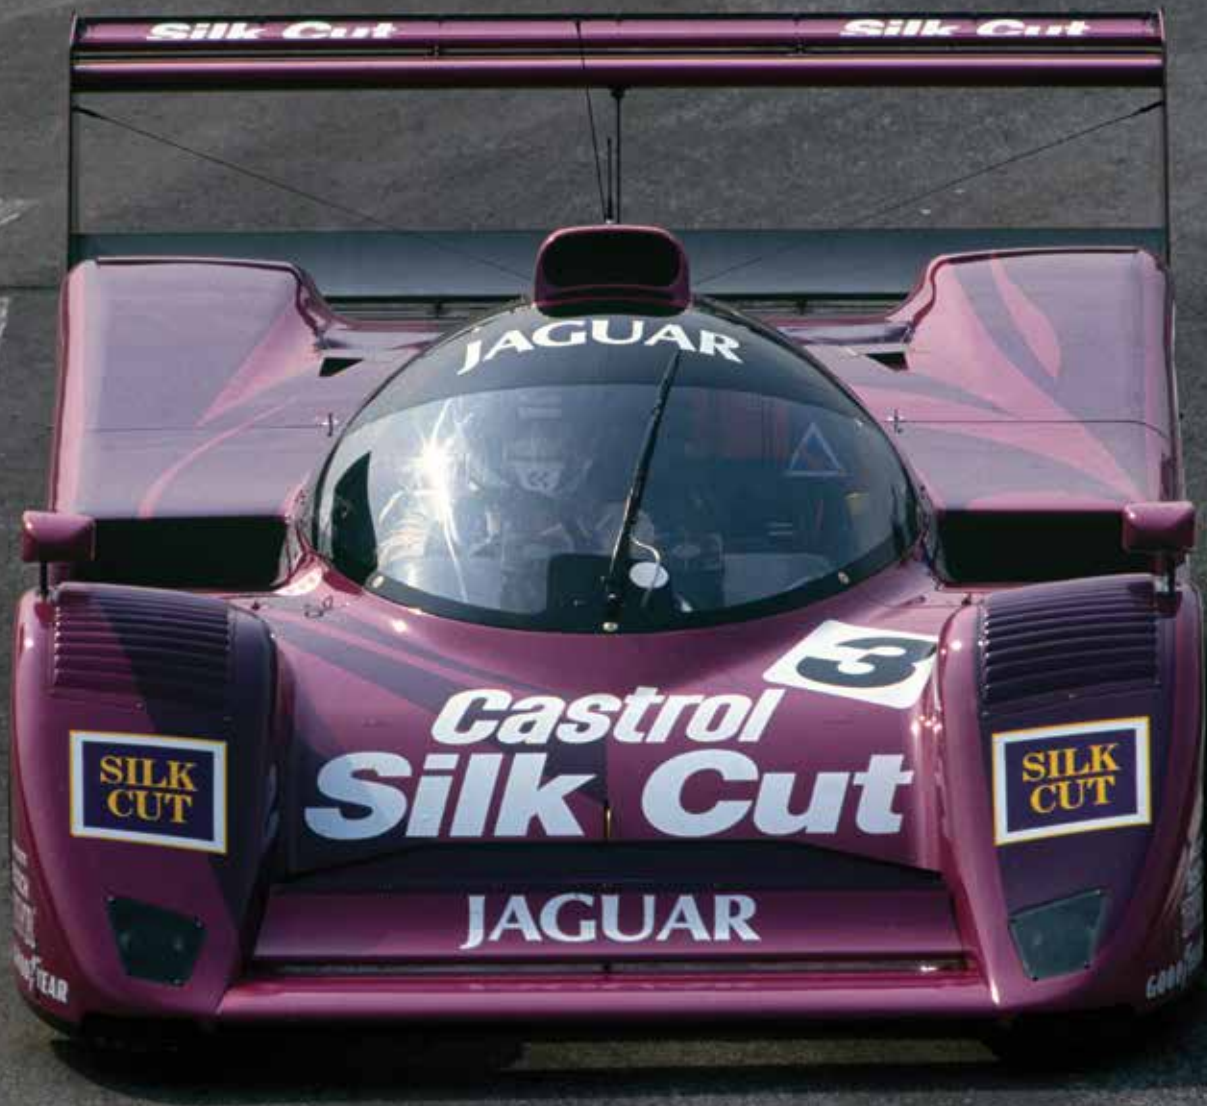
was extensive and consisted of the front and approximately two-thirds the length of the left side of the tub, where the front suspension pickup points, torsion bar, and rocker arms are all located; in the area of primary suspension loading. The XJR-14s had an internal longitudinal bulkhead off set from the primary monocoque wall and damage was transferred to this structure as well.

After a wheel failure at Lime Rock, damage was extensive to the front and some two-thirds of the left side of 591's tub

Scheme One entailed removing the damaged section and manufacturing new replacement sections, laid up out of the original mould and from the correct layup schedule. Given the location and nature of the repair, multiple new sections would have to be manufactured. To start, all the damaged sections would be removed as neatly as possible. Then the entire perimeter of the damaged area would then be offset by relieving the honeycomb back 25-30mm, in order to create lap joint for bonding. The replacement panels would then be dry fitted to the tub, to insure a precise fit, and then cold bonded with 3M 9323 structural adhesive, and riveted into place. After full adhesive cure the rivets would be drilled out and black-pigmented adhesive put into the resulting holes.

layups, the 'belts and braces,' on the outside and inside of the monocoque across the seam of the replacement sections, in order to tie everything together structurally. The work required on the inside of the tub meant abrading the surfaces to be laid up, laying up, and vacuum bagging around the off-set longitudinal bulkheads, in the very confined space of the foot well; a claustrophobic's nightmare. And in the end, all of this would have added substantially to the cost of the repair.

use of 3M's 9323 structural adhesive in the 1992 Scheme One repair would mean that a low temperature pre-preg composite would have to be used for the 2013 Scheme Two repair. The reason for this was 9323 lost substantial strength at temperatures above 180degF. So this limitation had to be taken in to consideration in order not to affect the strength of the original 1992 repair. Composite Technologies was able to source suitable low-temperature pre-preg from PRF Composite Materials out of Poole, Dorset, UK; a 2x2, 200g/sq m (gsm—denotes fabric weight and more importantly, relative ply thickness), twill fabric for the inner ply and a period-correct five-harness satin, 280gsm, outer ply.

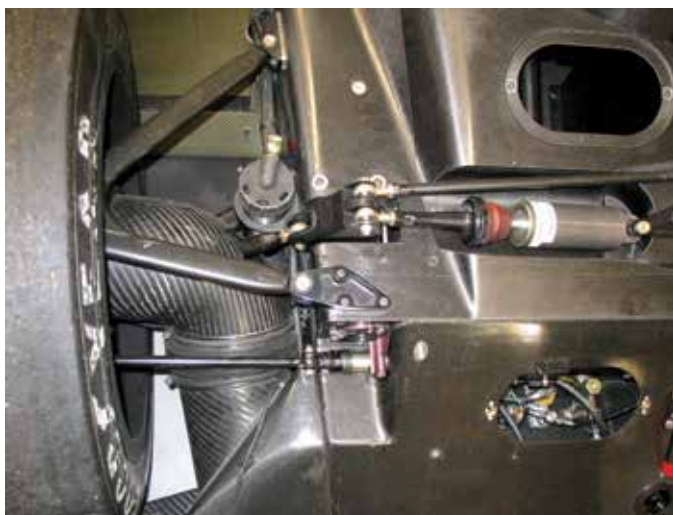
As you can see, any damage occurring to this highly loaded corner would be a real headache

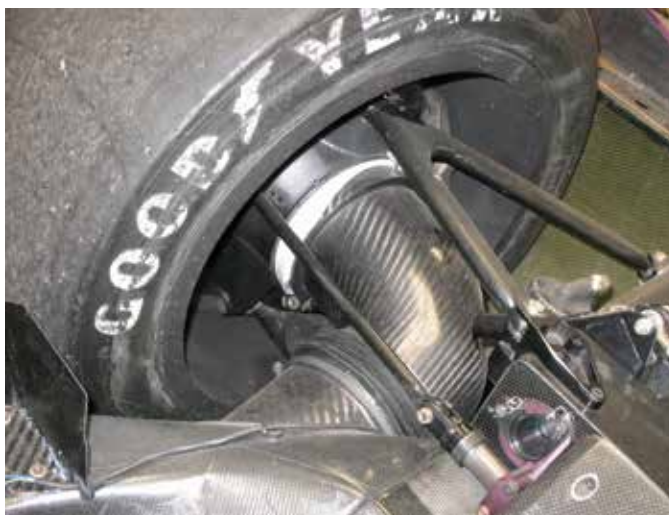
The high downforce nature of the US circuits in 1992 highlighted the Jaguar's weakness - wheel failure at Lime Rock led to a large accident

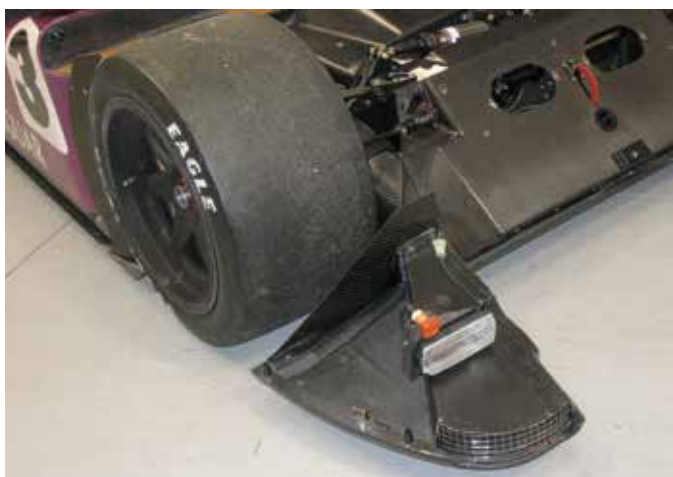
Three monocoques were manufactured for the original XJR-14 World Sportscar 1991 programme; chassis 591, 691 and 791

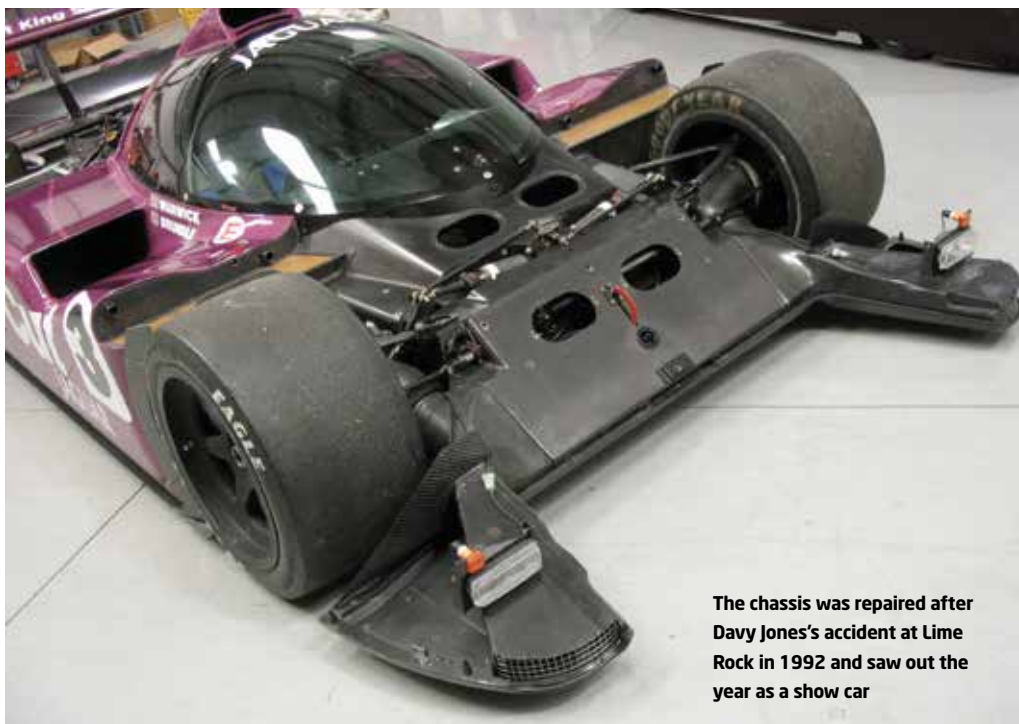
Given the intrinsic value of the car, reputedly upwards of \$3m, it was thought it would be prudent to 'prove' the effectiveness of the repairs

The chassis was repaired after Davy Jones's accident at Lime Rock in 1992 and saw out the year as a show car

And the results? Analysing the upper wishbone on the left-hand side, the forward leg mounting point averaged 7 per cent stiffer, while the aft leg mounting point averaged 8.5 per cent stiffer. The lower wishbone showed similar (13.8 per cent and 29.1 per cent stiffer for the front and aft wishbone legs respectively) as compared to the right. So too the pushrod mounting point - 8.5 per cent stiffer. Given the results, Delta Motorsport concluded in their report: '...the monocoque and its suspension mounting points are fit for purpose and have an acceptable stiffness level to receive on track loads.'

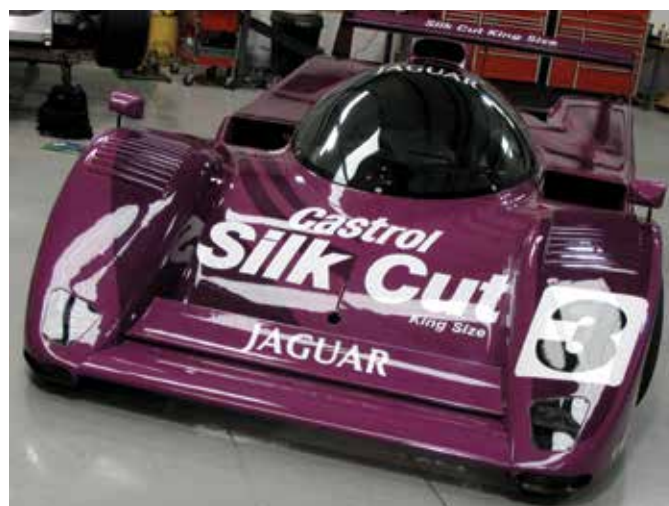
Chassis 591 has now been proven to be ready to race
